Application Note #1536

Mechanical Characterization of Corrosion-Resistant Coatings

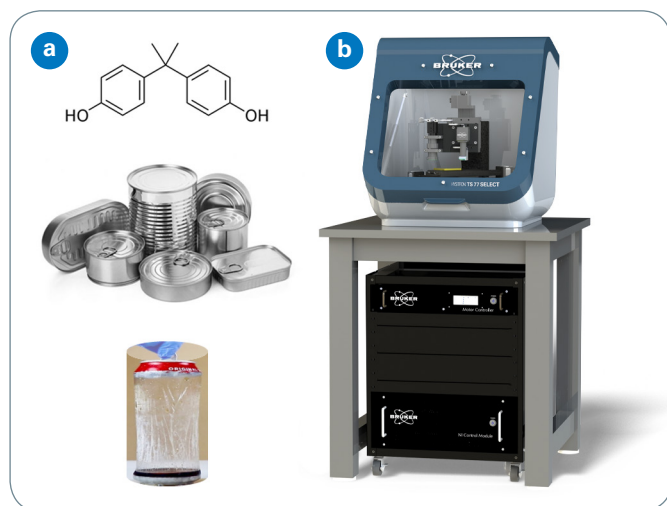
Figure 1. (a) Representative food and beverage can liner images; and (b) Bruker's Hysitron TS 77 Select benchtop indenter.

Three corrosion-resistant polymers from soft drinks of varying pH (10 mm x 10 mm), from different manufacturers, were attached (using Loctite 420) to metal discs, while maintaining the original can curvature. The liner coatings on these samples were in contact with highly acidic beverages for over one year. The pH values of the drinks are shown in Table 1. Surface topographical variations, as well as modulus changes, were mapped using the Hysitron TS 77 nanoindenter equipped with nanoDMA® III (Figure 1). Scratch resistance of the coatings was evaluated using Bruker's two-dimensional capacitive transducer.

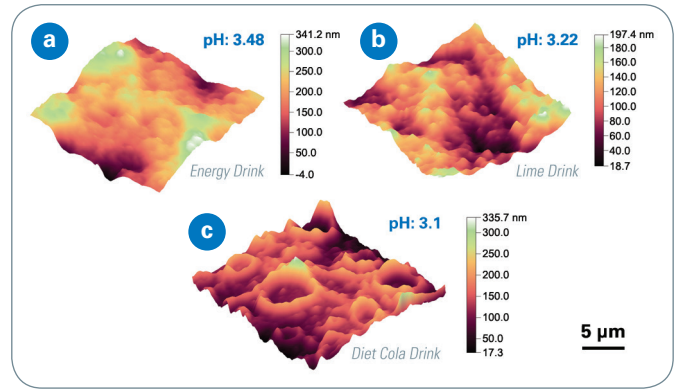
Figure 2. Scanning probe microscopy images showing variation in surface topography on beverage can coatings.

Epoxy coatings that were in contact with the acidic drinks showed marginal surface degradation. Scanning probe microscopy images showed surface pits on the sample exposed to diet cola drink, with a pH of 3.1 (Figure 2). A continuous measurement of hardness and modulus as a function of depth, using Bruker’s CMX, increases data acquisition throughput. By doing automated constant strain rate CMX, indents using a Berkovich probe, large area modulus maps were created. Figures 3a-c show variation in modulus as a function of depth at different spatial coordinates. While Figures 3d-f show representative modulus versus contact depth curves for three epoxy coatings.

variation seen in Figure 3 could be due to the curing process or induced by acidic beverage drink. At the macro scale, epoxy coatings looked intact. However, nanoscale topographical measurements (Figure 2c) showed nano pits on the coatings exposed to the highly acidic diet cola drink. Coatings used in soft drink storage are known to withstand acidic environments, and it is highly unlikely that chemical reaction resulted in nano pits. Studies indicate the degradation mechanism on such coatings is physical in nature and induced by swelling stresses.³
